**FIELD ACTIVITIES OVERSIGHT REPORT  
GULFCO MARINE MAINTENANCE SITE, FREEPORT, TEXAS  
OVERSIGHT AND SPLIT SAMPLING ACTIVITIES  
CONDUCTED FROM 27 NOVEMBER – 7 DECEMBER 2006**

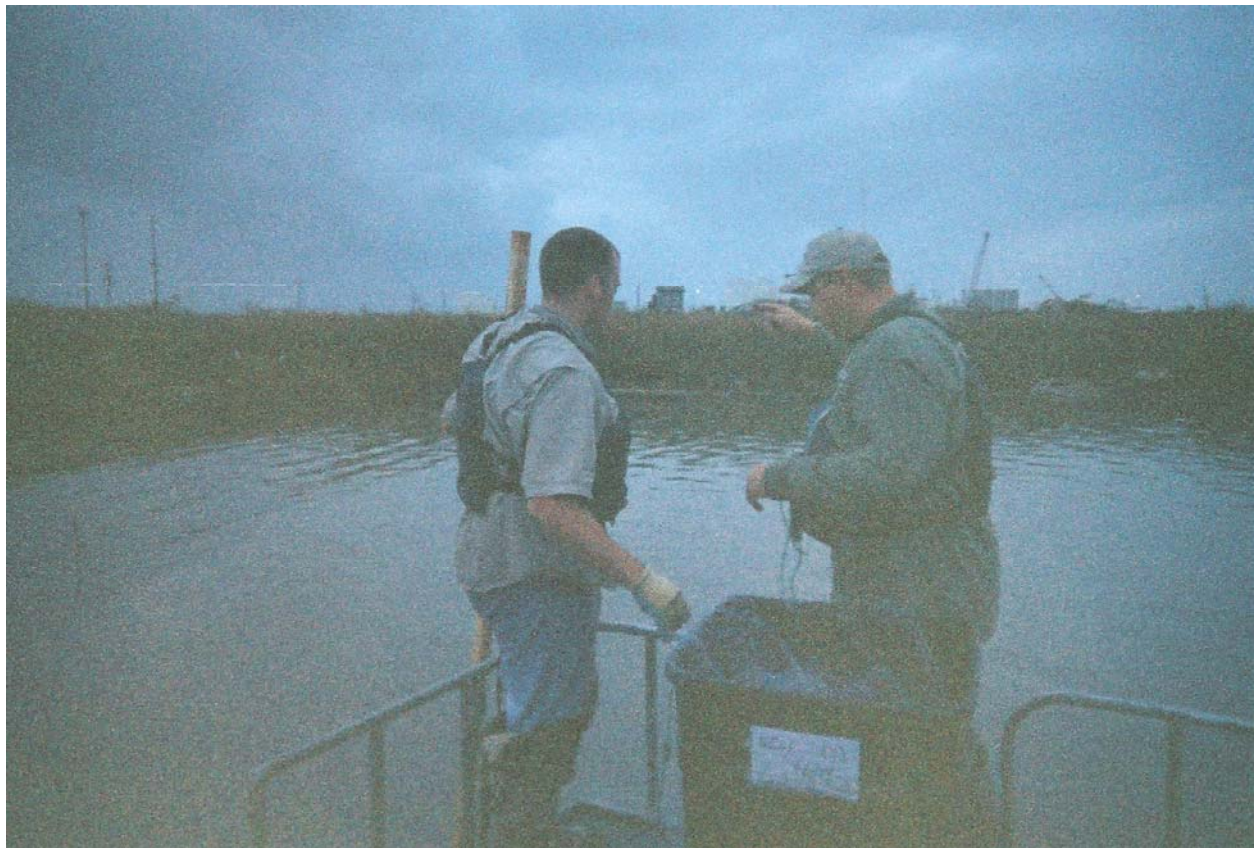
Photograph No. 1      Date: 27 November 2006      Site: Gulfco Marine Maintenance Superfund Site  
Description: Attaching gill net to post at Zone 1

From 1604 – 1923 hours, EA conducted oversight of BESI, while they set 3½- and 5-inch gill nets in Zones 1 through 4 and the Background Area (Photographs 1 – 4).

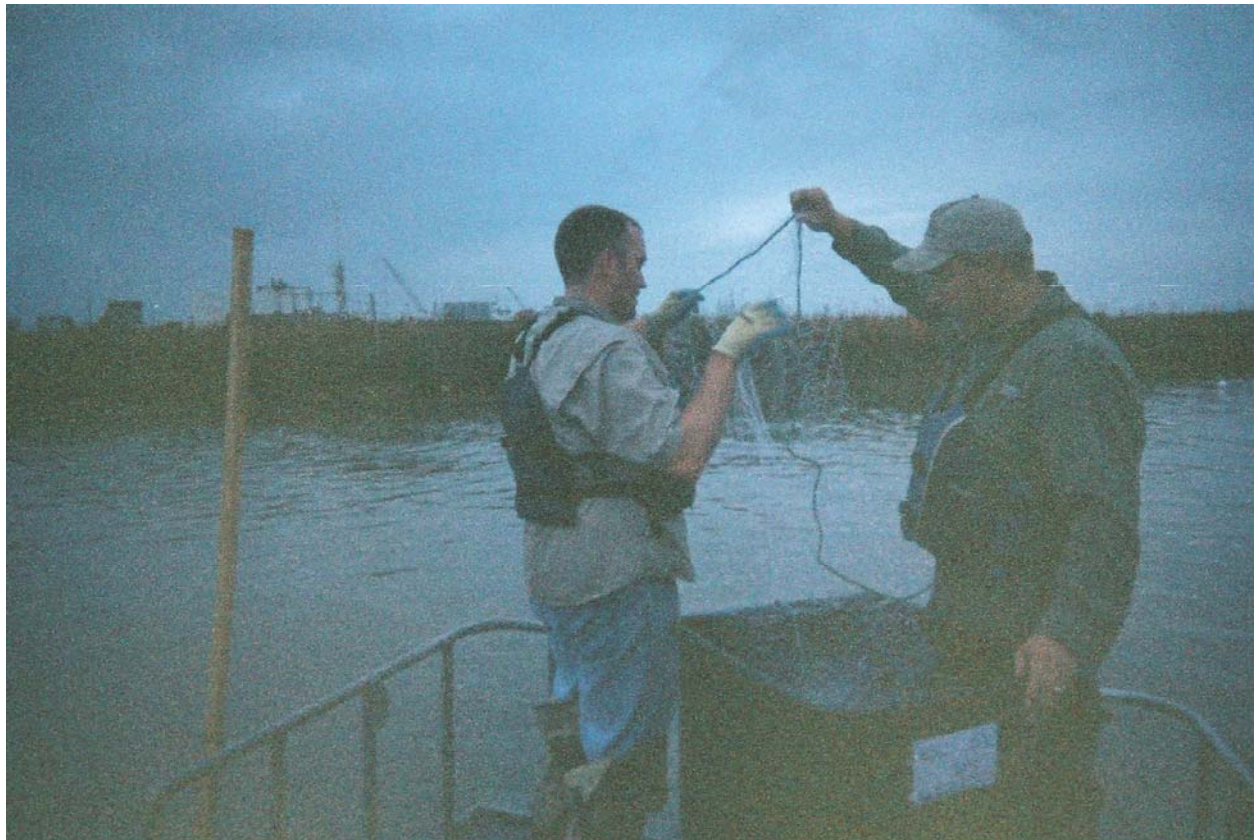
Photograph No. 2      Date: 27 November 2006      Site: Gulfco Marine Maintenance Superfund Site  
Description: Setting gill net at Zone 1

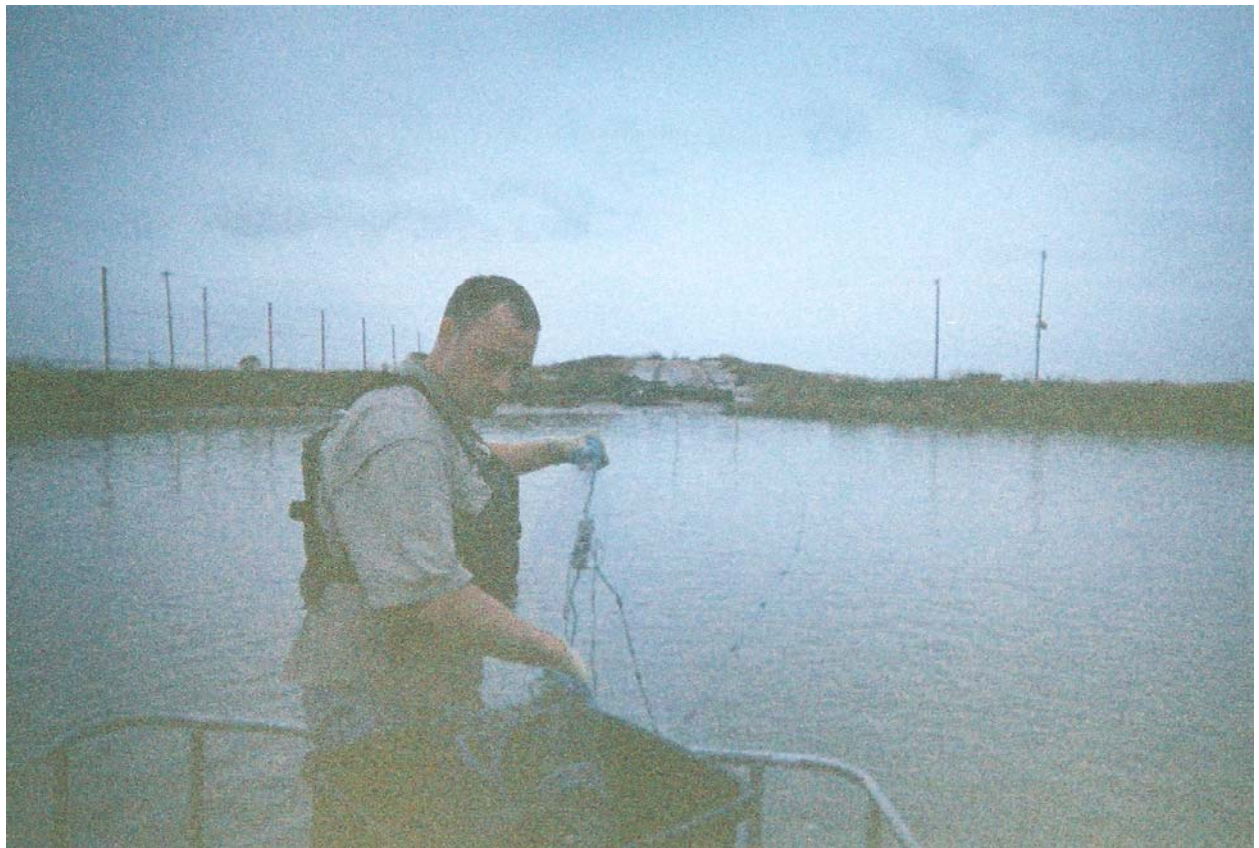
Photograph No. 3      Date: 27 November 2006      Site: Gulfco Marine Maintenance Superfund Site  
Description: Straightening (pulling taught) gill net at Zone 1

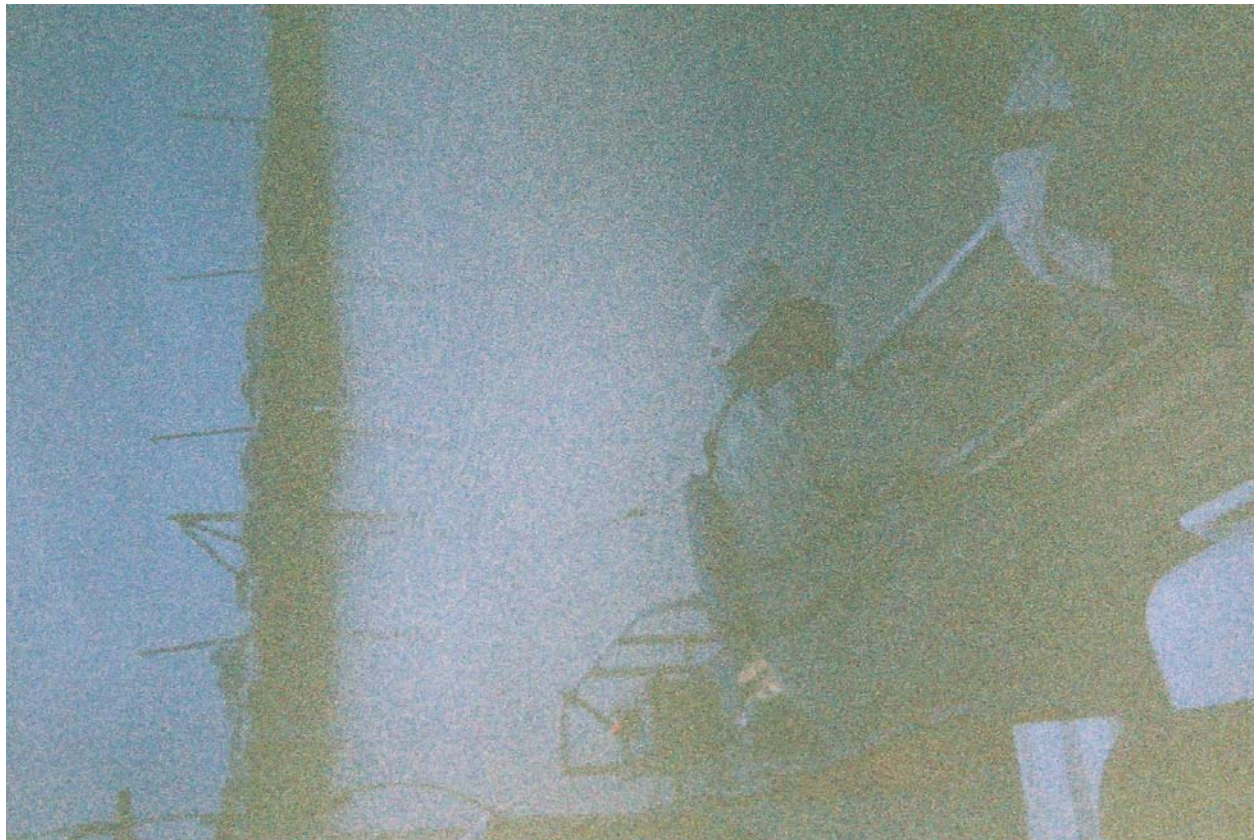
Photograph No. 4      Date: 27 November 2006      Site: Gulfco Marine Maintenance Superfund Site  
Description: Attaching end of gill net to post at Zone 1

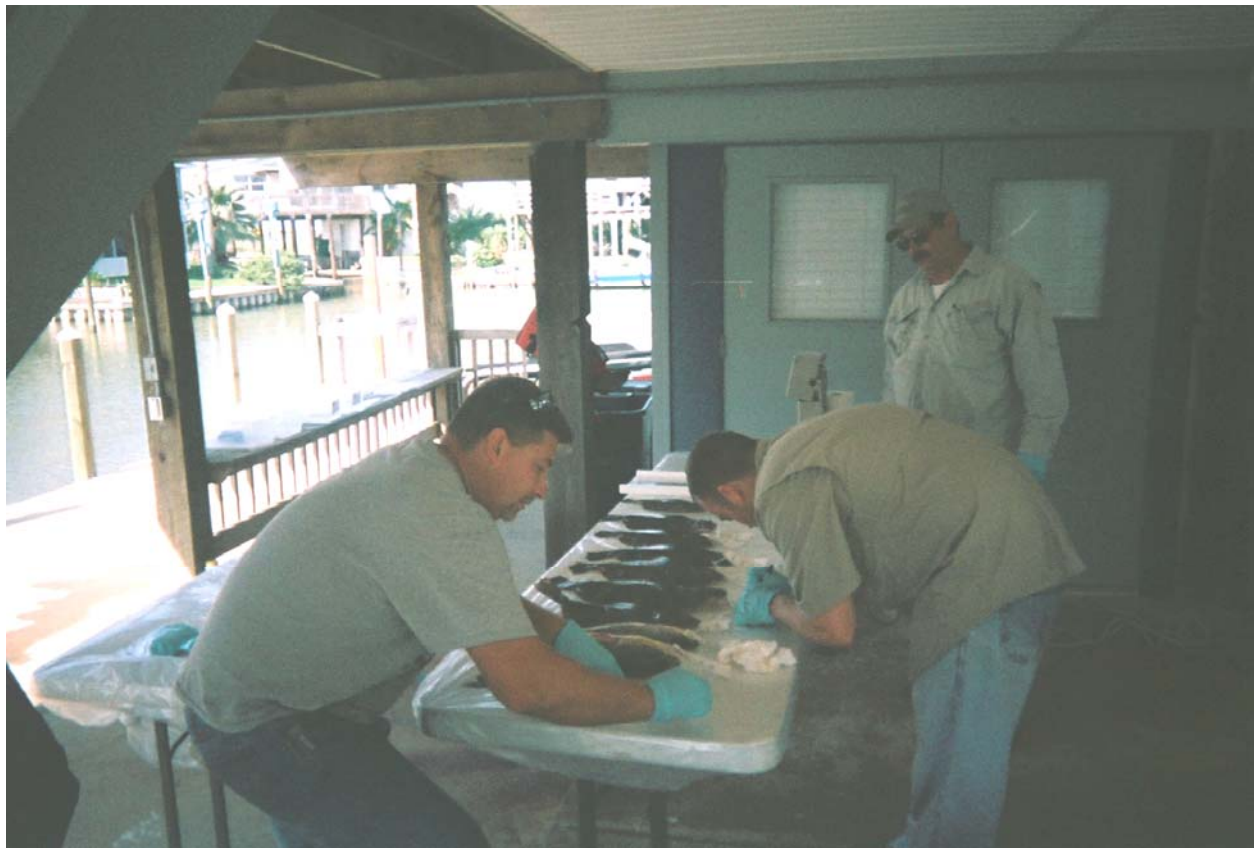
Photograph No. 5      Date: 28 November 2006      Site: Gulfco Marine Maintenance Superfund Site  
 Description: Cataloging, labeling, and inspecting fish

At 1058 hours, BESI began processing fish collected from the Background Area, including 7 southern flounder, 1 spotted sea trout, 1 red drum, and 1 black drum (Photographs 5 and 6).

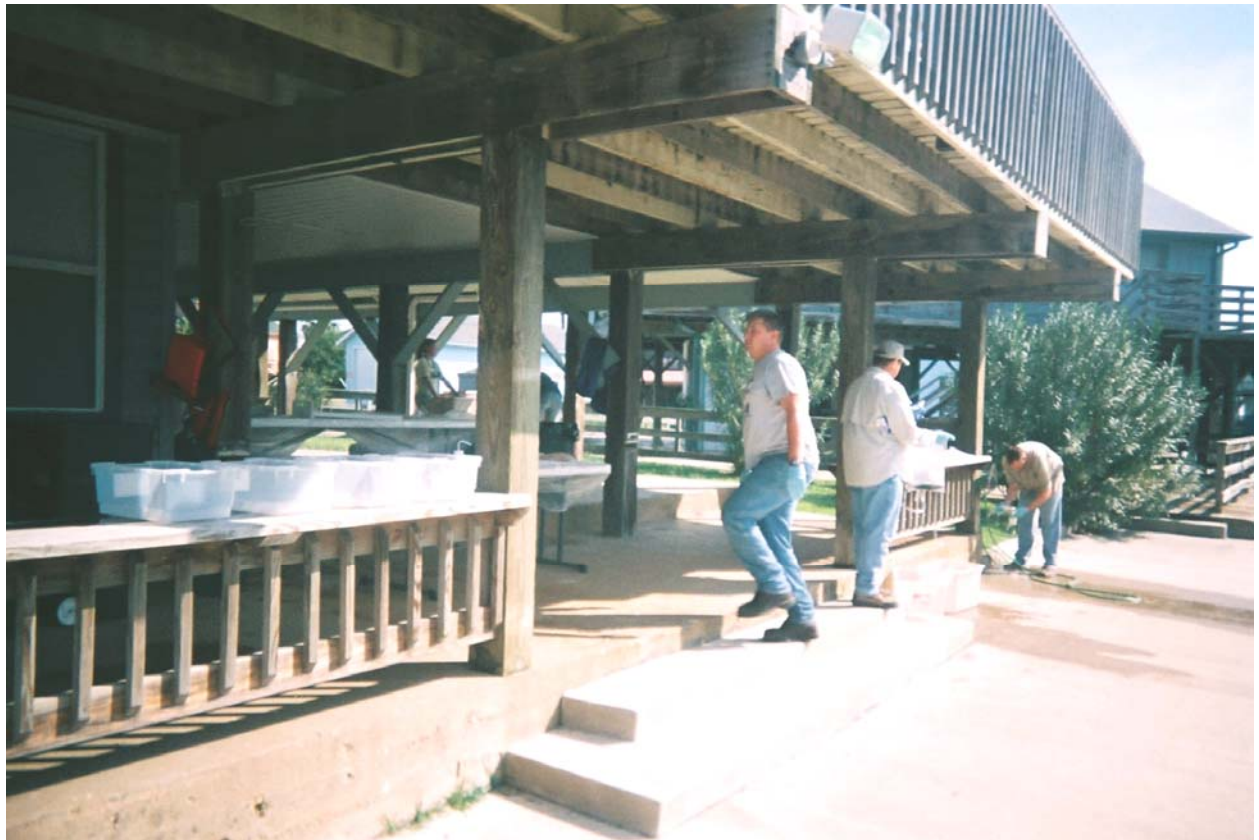
Photograph No. 6      Date: 28 November 2006      Site: Gulfco Marine Maintenance Superfund Site  
 Description: Decontamination areas used in biota processing

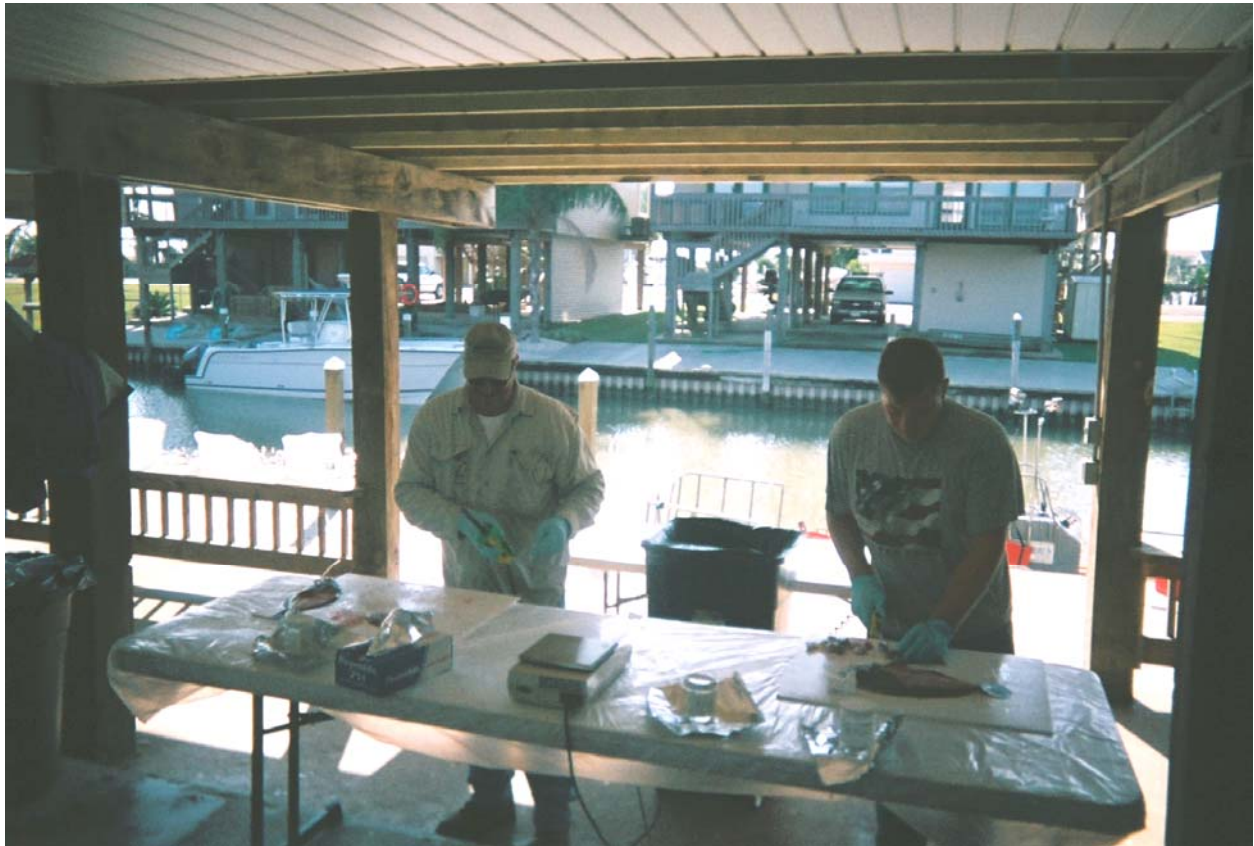
Photograph No. 7      Date: 28 November 2006      Site: Gulfco Marine Maintenance Superfund Site  
Description: Filleting, weighting, and packaging fish filet samples

At 1300 hours, BESI began collecting a sample subset of the spotted sea trout collected from Zone 1 (EA split sample IWST00102-EPA). BESI processed and sampled the fish tissue in adherence with PBW's SAP (May 2006) and Addenda to the FSP and QAPP (November 2006), and BESI SOP 509 (Fish Tissue Processing) with the one exception: rather than weighing the fillets on hexane-rinsed aluminum foil, the fillets were cut into cubes, and placed into tared sample containers, which were then re-weighed (Photograph 7).

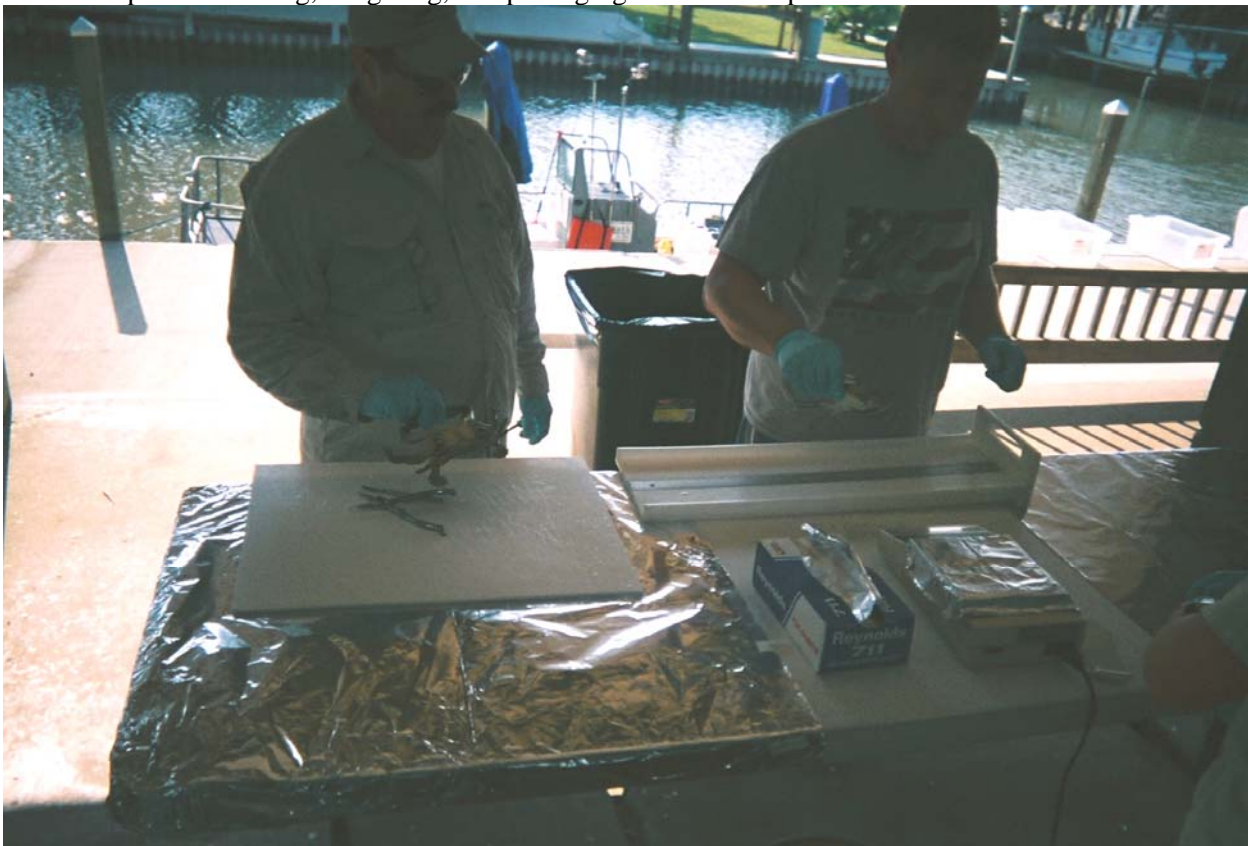
Photograph No. 8      Date: 28 November 2006      Site: Gulfco Marine Maintenance Superfund Site  
Description: Measuring and weighing blue crab samples

At 1336 hours, BESI began processing blue crab collected from the Site Area (Zone 2) and the Background Area (Photograph 8). USFWS noted no morphologies or ulcers on any of the crabs collected.

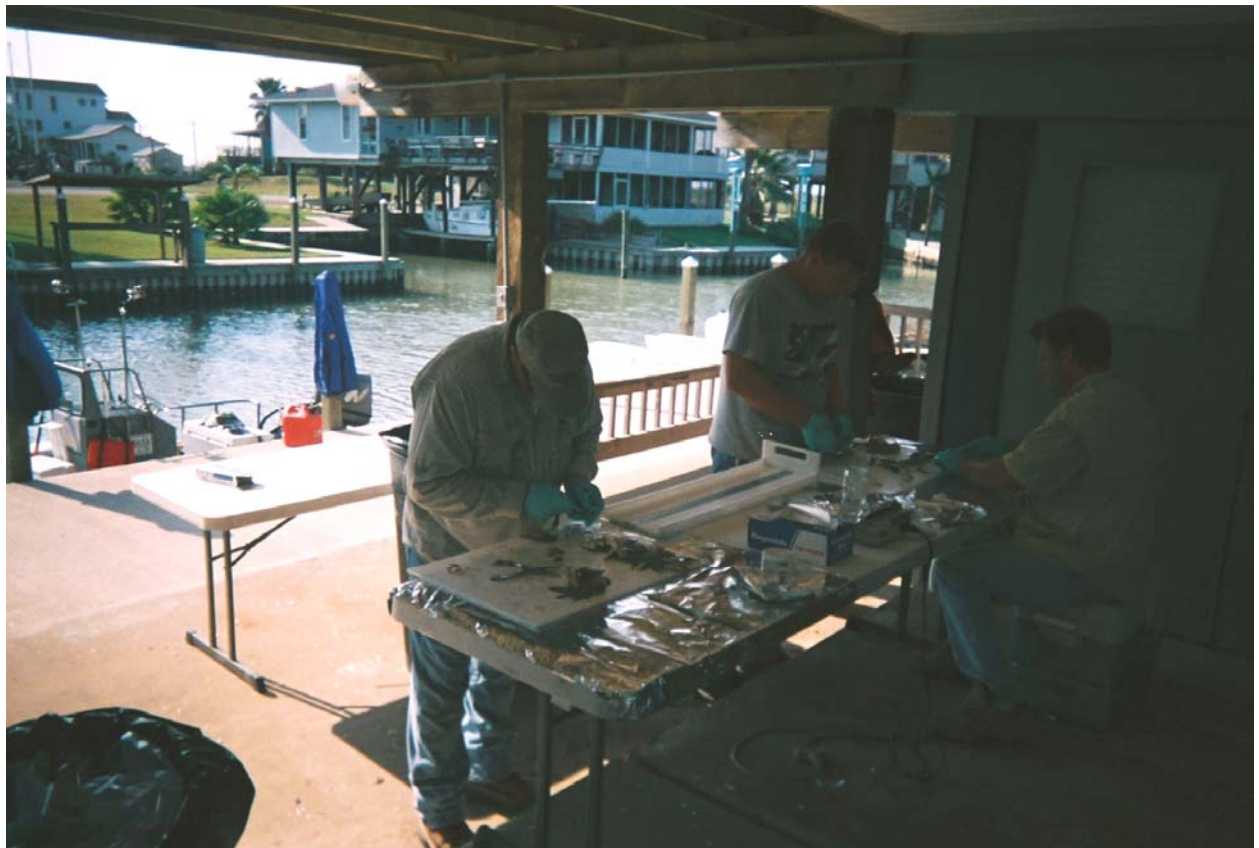
Photograph No. 9      Date: 28 November 2006      Site: Gulfco Marine Maintenance Superfund Site  
Description: Processing, weighing, and packaging crab samples

At 1505 hours, BESI began collecting a sample subset of the blue crab collected from the Background Area (Photograph 9). BESI processed and sampled the blue crab in adherence with PBW's SAP (May 2006) and Addenda to the FSP and QAPP (November 2006), as well as BESI's SOP 507 (Crab Tissue Processing). EA did obtain a split sample for this location.

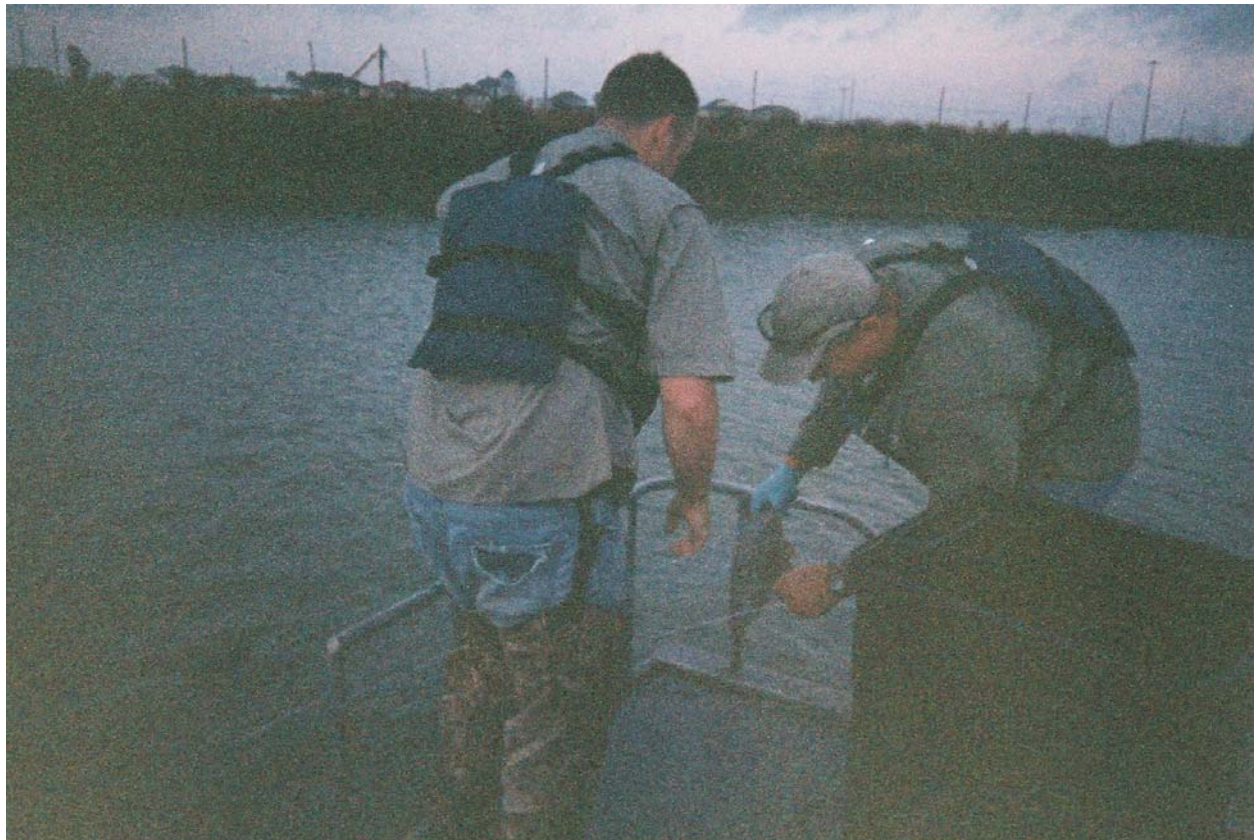
Photograph No. 10      Date: 29 November 2006      Site: Gulfco Marine Maintenance Superfund Site  
Description: Collecting fish from gill net

From 0629 – 0954 hours, EA provided oversight of BESI's morning fish and crab collection activities (Photographs 10 – 15). BESI collected fish and crab specimens in adherence with PBW's SAP (May 2006) and Addenda to the FSP and QAPP (November 2006), as well as BESI's SOP 303 (Collection of Finfish and Crab Using Gill Nets) and SOP 304 (Collection of Blue Crab Using Commercial Crab Traps). During the morning haul, BESI collected 10 blue crabs and 1 sheepshead from the Site Area (Zones 1 and 2); and 15 blue crabs, 1 red drum, 1 southern flounder, and 1 sheepshead from the Background Area.

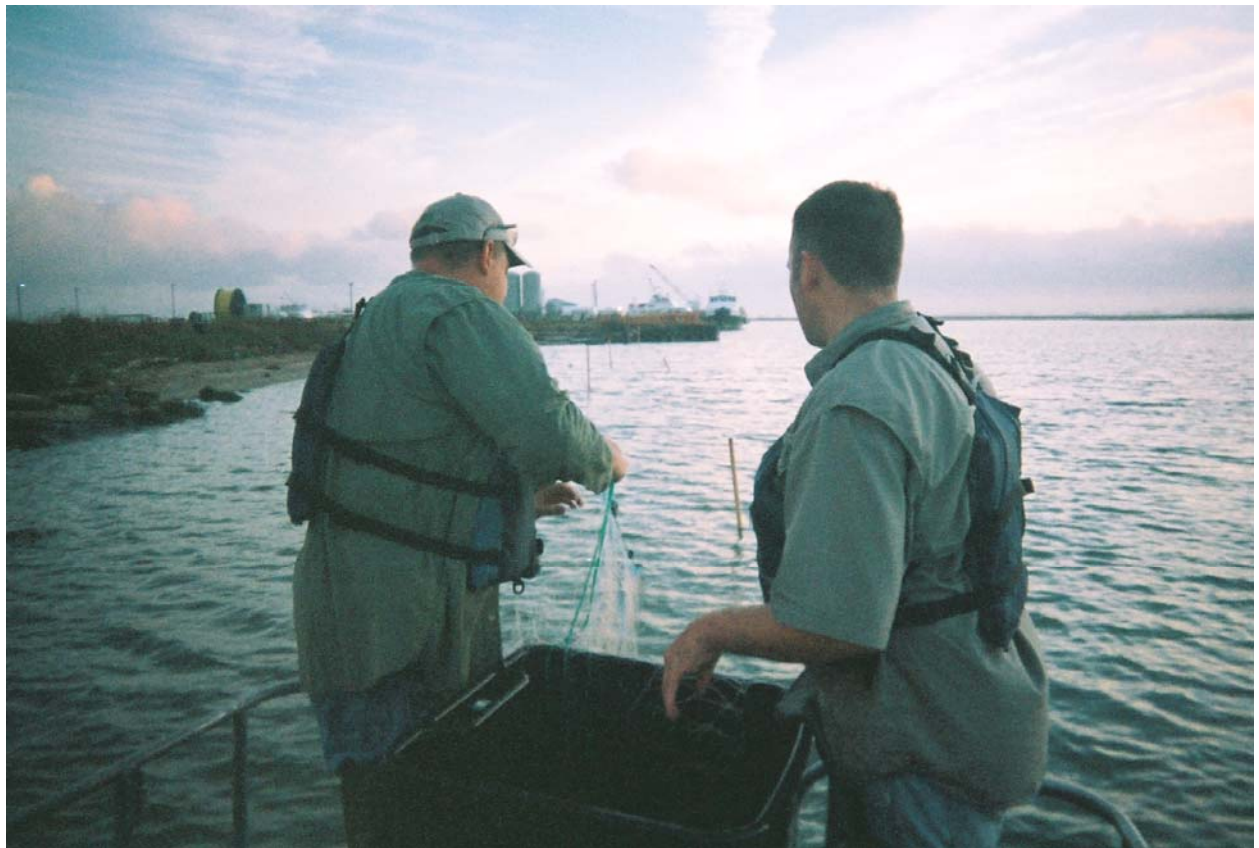
Photograph No. 11    Date: 29 November 2006    Site: Gulfco Marine Maintenance Superfund Site  
Description: Removing gill nets from Zone 3

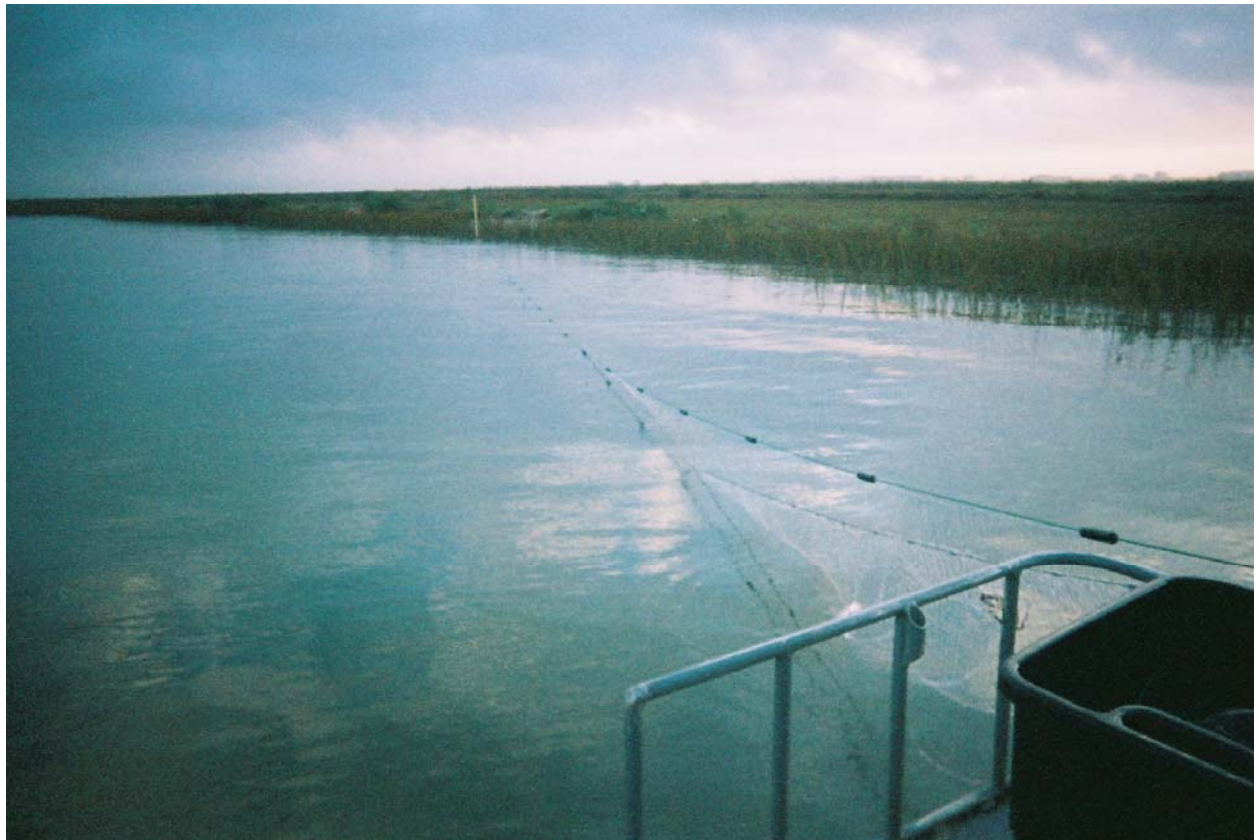
Photograph No. 12    Date: 29 November 2006    Site: Gulfco Marine Maintenance Superfund Site  
Description: Checking gill nets at Background Area

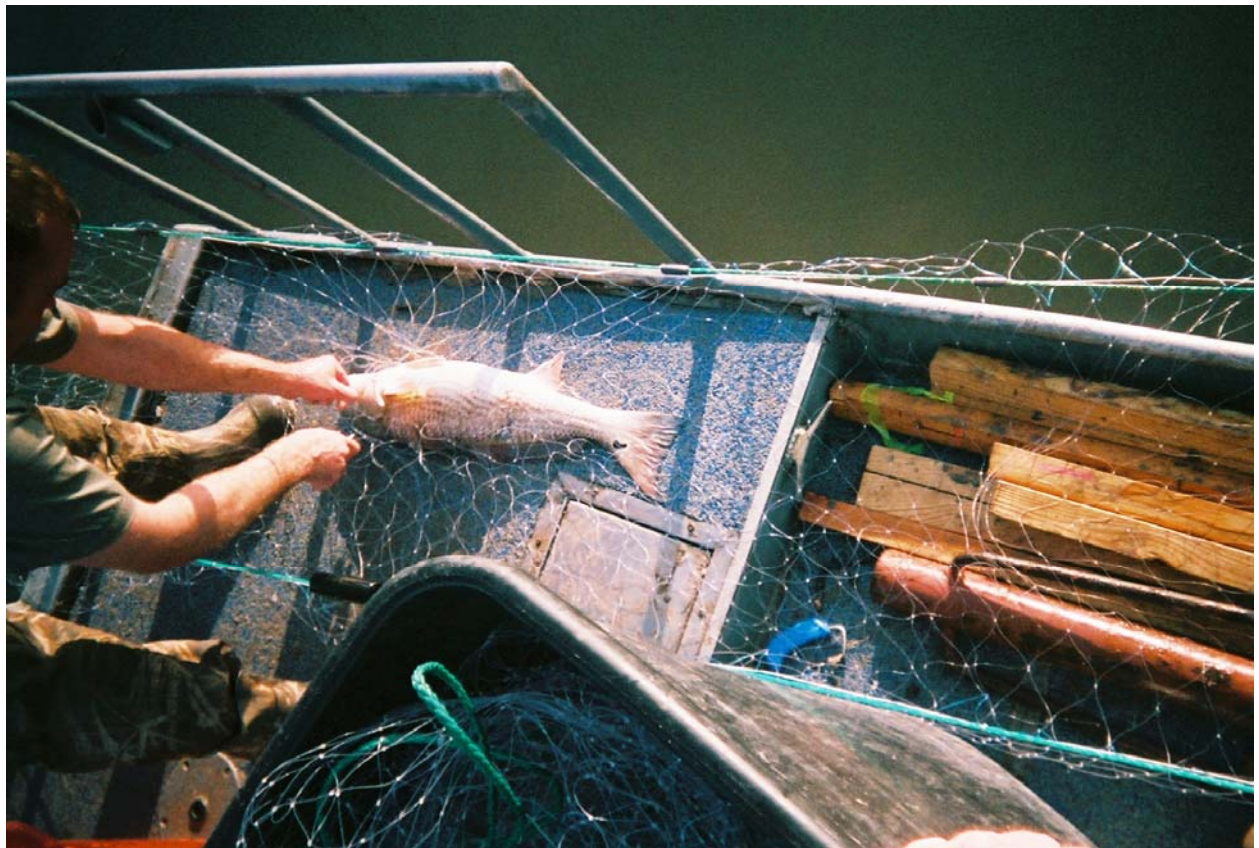
Photograph No. 13    Date: 29 November 2006    Site: Gulfco Marine Maintenance Superfund Site  
Description: Collecting red drum from gill net at Background Area

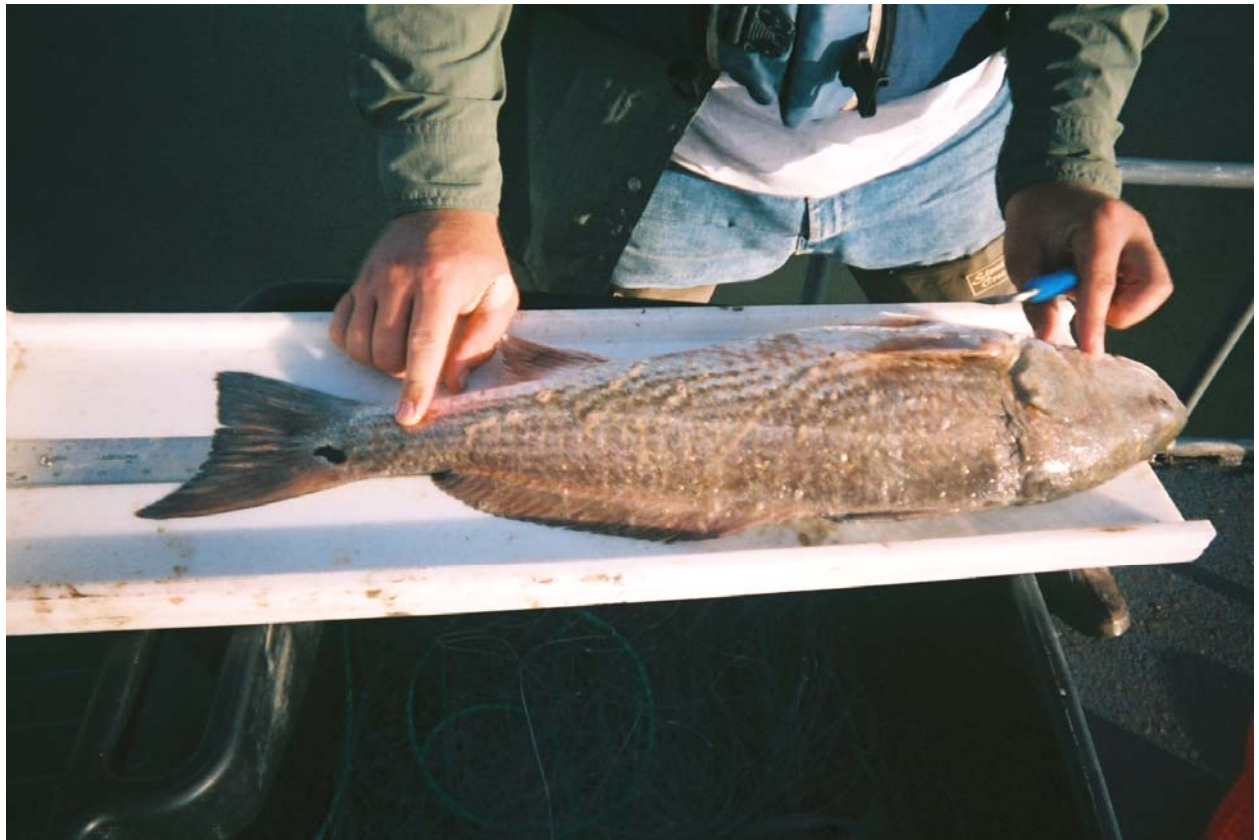
Photograph No. 14    Date: 29 November 2006    Site: Gulfco Marine Maintenance Superfund Site  
Description: Measuring red drum from Background Area

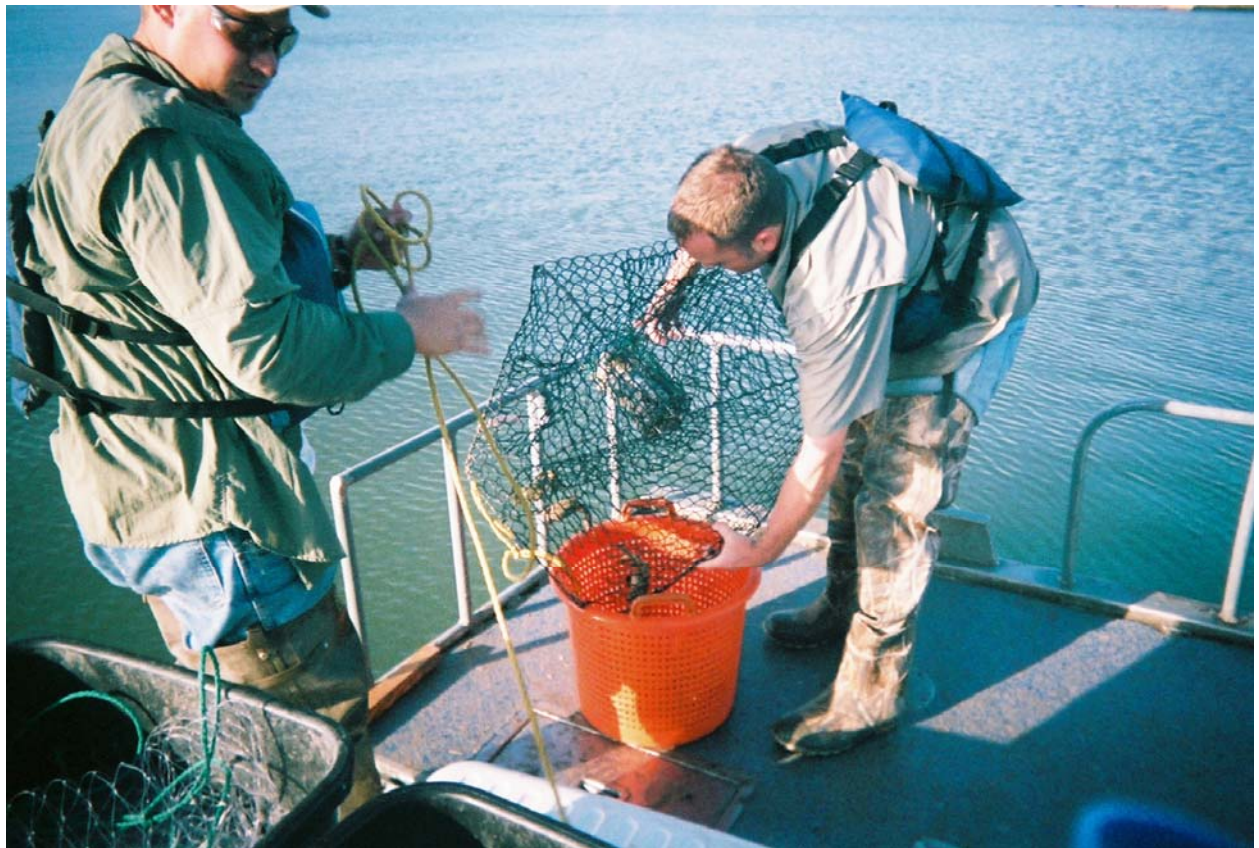
Photograph No. 15    Date: 29 November 2006    Site: Gulfco Marine Maintenance Superfund Site  
Description: Collecting blue crab from Background Area

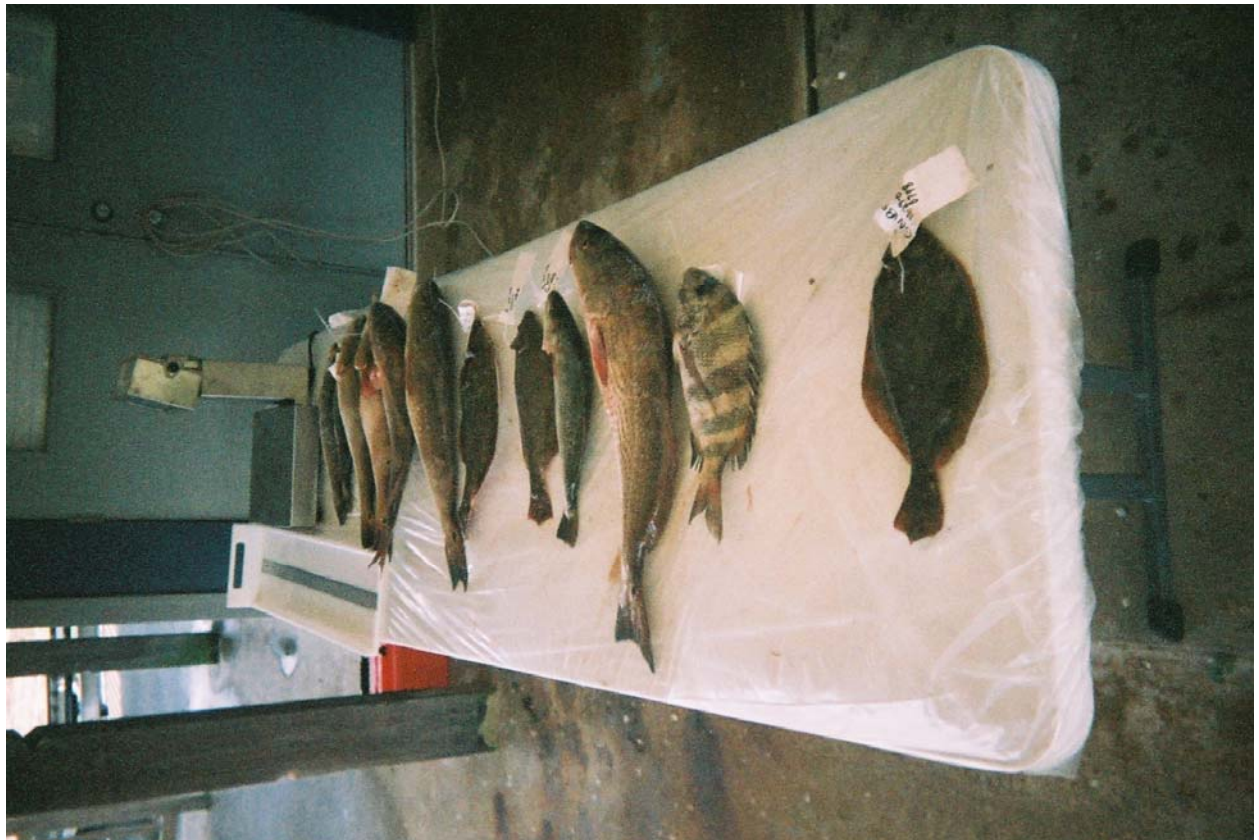
Photograph No. 16    Date: 29 November 2006    Site: Gulfco Marine Maintenance Superfund Site  
Description: Categorizing and labeling fish from Background Area

At 1029 hours, BESI began processing fish collected from the Background Area, including 2 southern flounder, 3 spotted sea trout, 5 red drum, and 1 sheepshead (Photograph 16). BESI collected fish tissue samples following the same protocol outlined above.

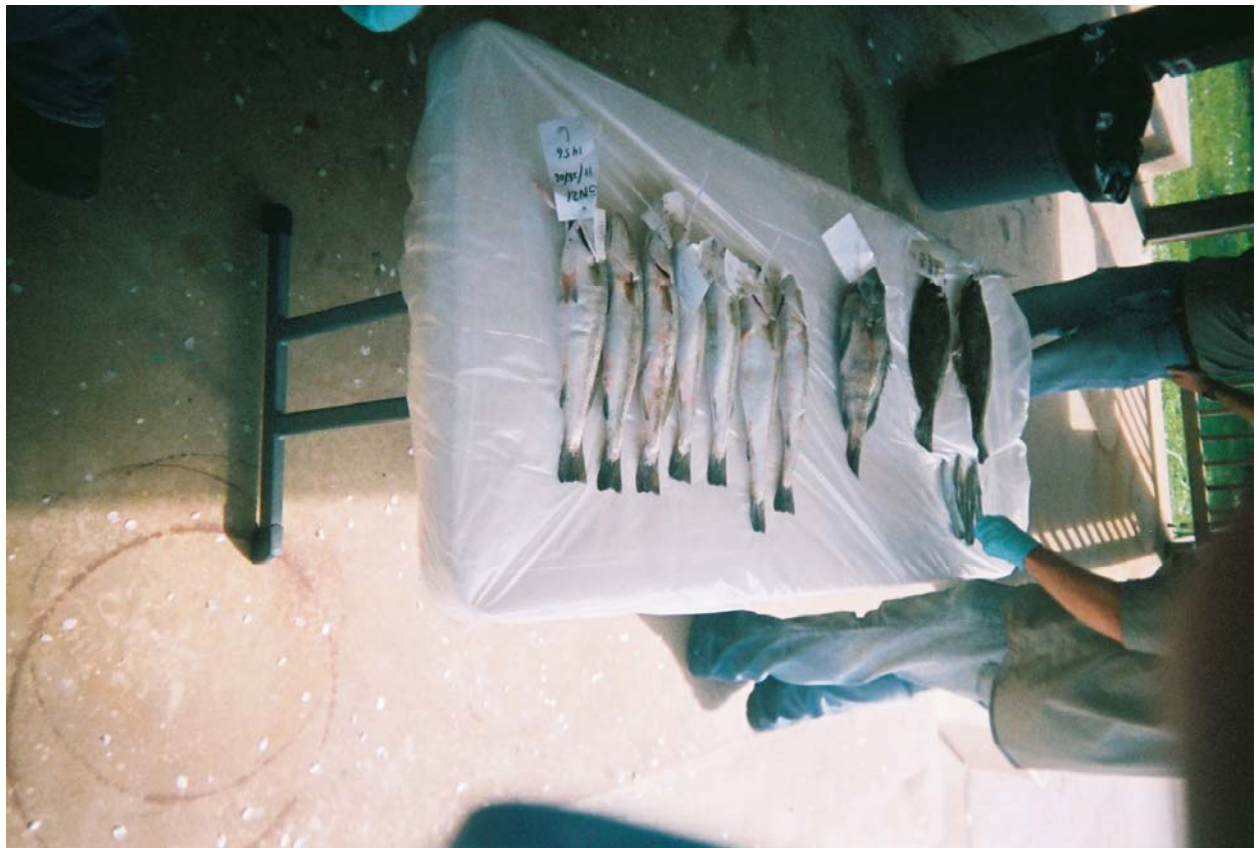
Photograph No. 17    Date: 29 November 2006    Site: Gulfco Marine Maintenance Superfund Site  
Description: Categorizing and labeling fish from Site Area

At 1135 hours, BESI began processing fish collected from Zones 1 and 2, including 2 southern flounder, 7 spotted sea trout, and 1 sheepshead (Photograph 17). BESI collected fish tissue samples following the same protocol outlined above. No target species of finfish were caught in the Zone 3 and 4 gill nets.

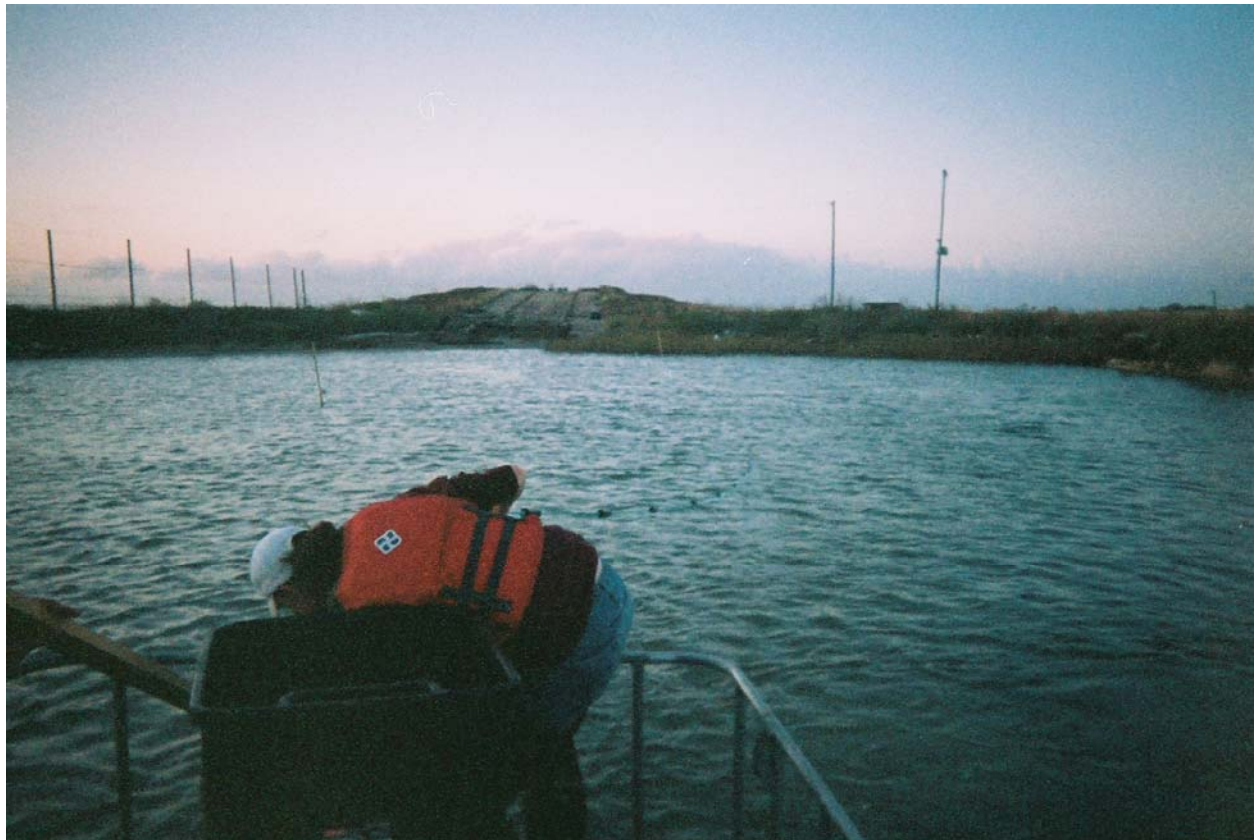
Photograph No. 18    Date: 29 November 2006    Site: Gulfco Marine Maintenance Superfund Site  
Description: Setting gill nets at Zone 1

From 1658 – 1729 hours, EA provided oversight of BESI personnel resetting the gill nets for that evening's catch in Zones 1 and 2 only (Photograph 18).

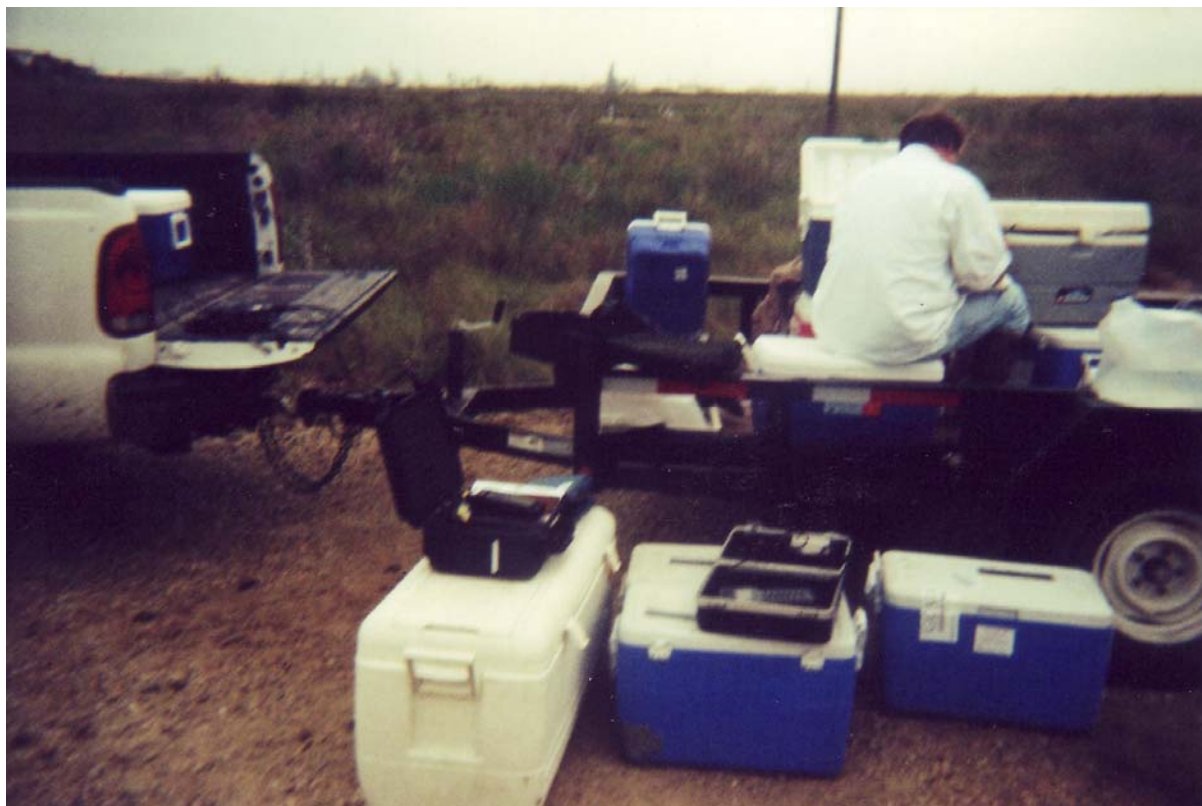
Photograph No. 19    Date: 6 December 2006    Site: Gulfco Marine Maintenance Superfund Site  
Description: BESI sediment/surface water staging and sampling area

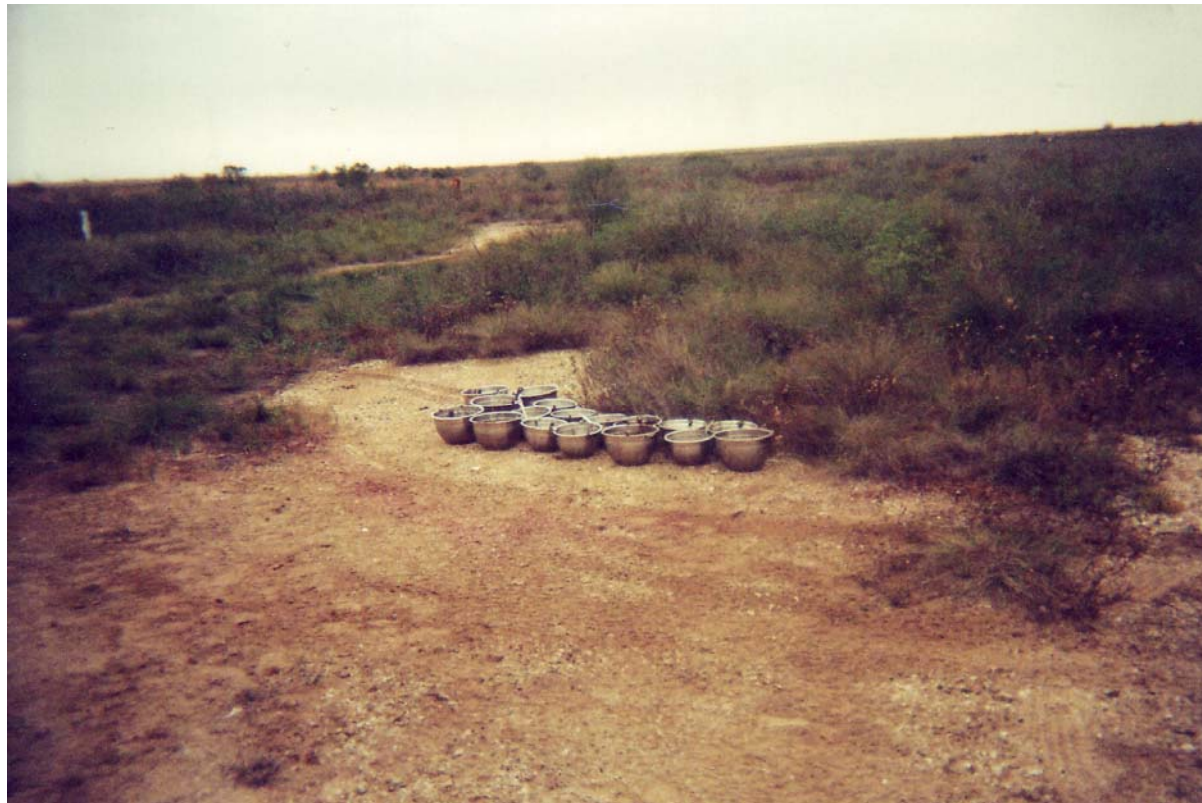
Photograph No. 20    Date: 6 December 2006    Site: Gulfco Marine Maintenance Superfund Site  
Description: BESI stainless-steelware used to composite sediment samples
